Simulations to verify projects

The simulations allowed us to verify the correct insulation coordination of a high voltage Gas Insulated Station (GIS).

Case Study no. 11: Very-fast-front overvoltages

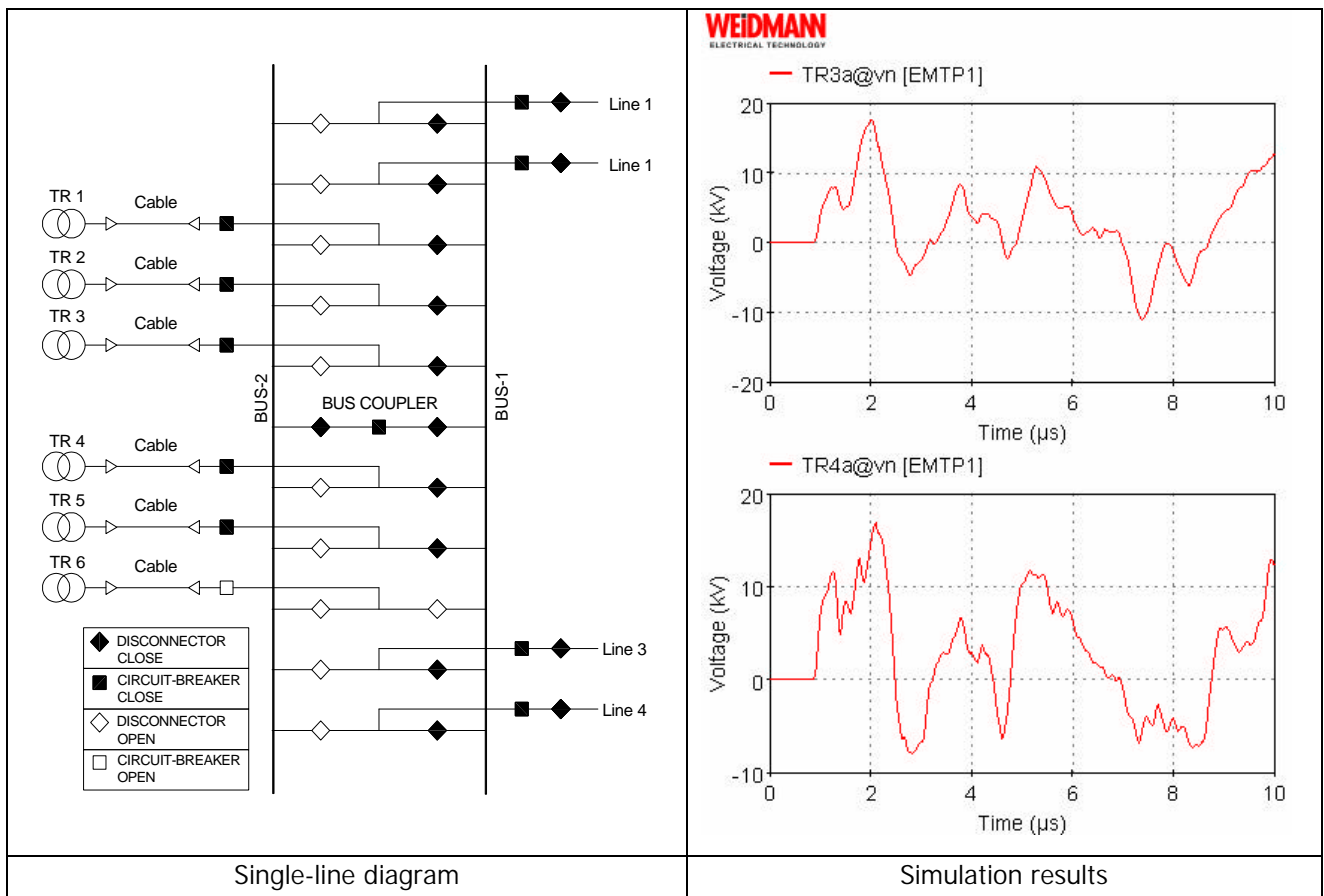
4. Results

The highest value obtained was only about 1.23 p.u. (in case of very unlikely operation) and the encountered frequencies, about 14 MHz, as expected.

Calculated transients on HV GIS substation did not put into evidence any critical overvoltage values. The results shows negligible surges and we can conclude that no fault due to disconnectors/circuit-breaker should be experienced!
