Simulations permit upgrade

Case Study 2: GSU Transformer Upgrade – Tank Hot Spot

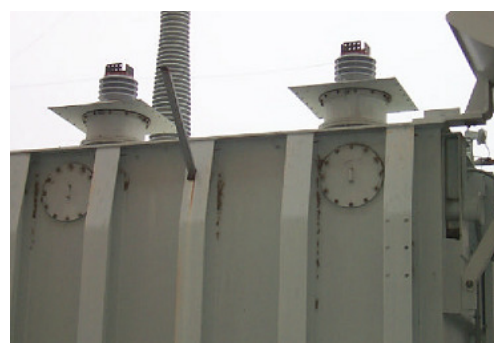
Side view (shorting plate disassembled)

- Aluminium shields inside the tank, mild steel tank wall and non magnetic steel cover parts had to be taken into account
- A 3-dimensional modelling was necessary
- Close cooperation with the manufacturer of the enclosure and quick delivery of the simulations were a must in order to identify a solution in time for the scheduled maintenance of the power plant
